September 2013

Safety Recall N28 / NHTSA 13V-234

Transmission Oil Cooler Tube

2012 - 2013 (JK) Jeep® Wrangler

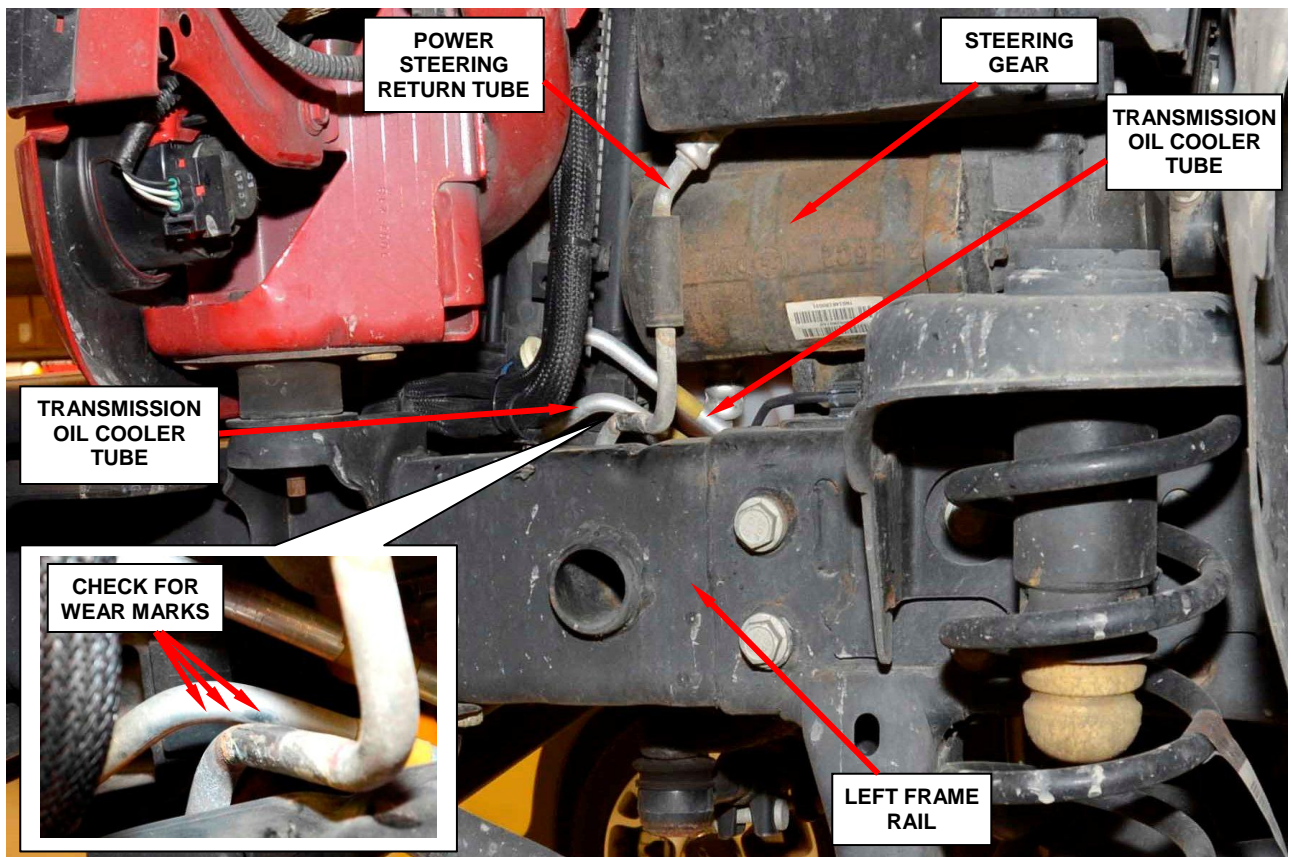
Figure 3 – Inspect the Transmission Oil Cooler Tube at the Power Steering Return Tube for Wear Marks

7. Using a small inspection mirror, check for wear marks on the transmission oil cooler tube where it intersects with the power steering return tube:
 - If the transmission oil cooler tube does not have any wear marks, continue with Step 8 of this procedure.
 - If the transmission oil cooler tube has wear marks, continue with **Section C. Replace Transmission Oil Cooler Tube.**

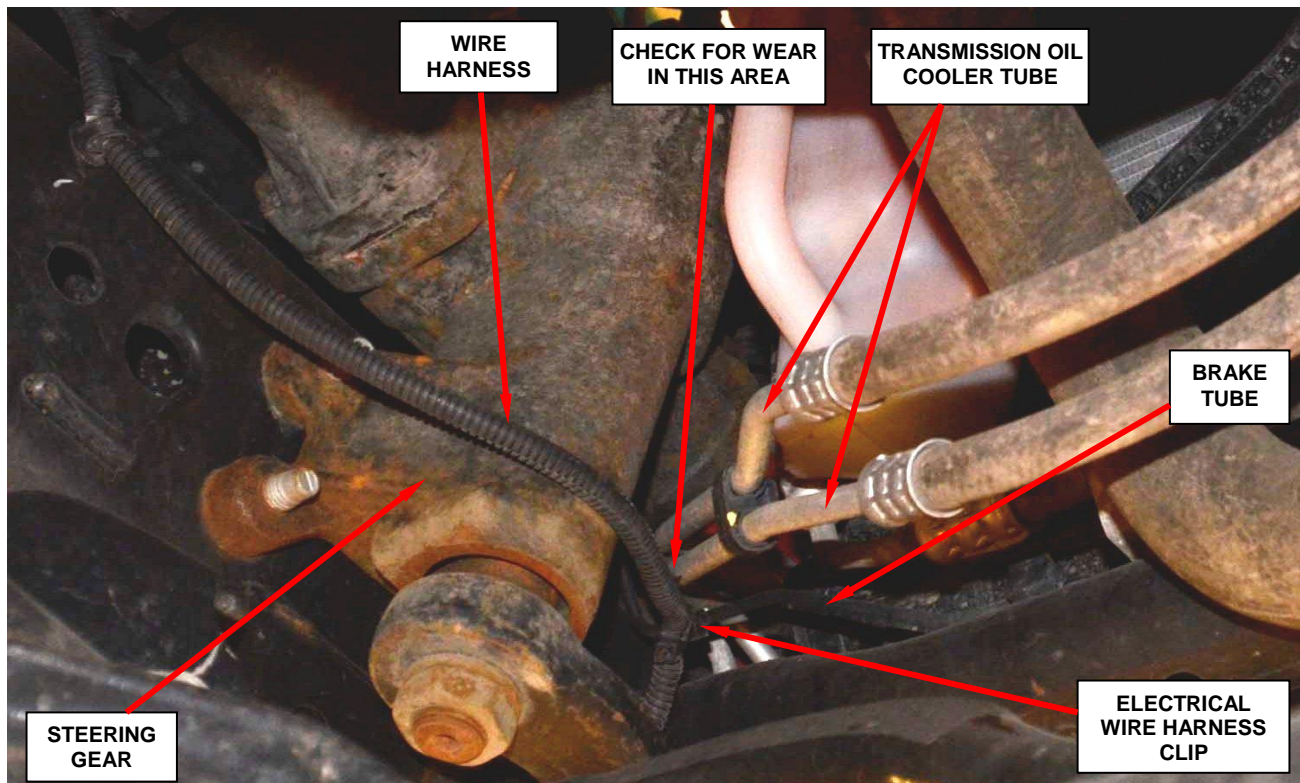
Figure 4 – Inspect Transmission Oil Cooler Tube for Wear Marks at the Wire Harness

11. Inspect the transmission oil cooler tube for wear marks where the electrical body harness crosses the transmission oil cooler tube (Figure 4):
 - If the transmission oil cooler tube does not have any wear marks, continue with **Section B. Install Transmission Oil Cooler Tube Protective Sleeve.**
 - If the transmission oil cooler tube has wear marks, continue with **Section C. Replace Transmission Oil Cooler Tube.**

8. Lift the vehicle on the hoist.
9. Unclip the electrical wire harness from the brake tube (Figure 4).
10. Using diagonal cutters cut off the electrical wire harness clip that supports the wire harness at the brake tube (Figure 4).

NOTE: The electrical wire harness clip referenced in Step 10 will not be reused. The clip is being eliminated and the wire harness should hang freely. Use care not to cut the wire harness or the plastic convolute cover.
